# Manhole Inspection Summary

Manhole # S23UU1010MH

**Location** Address: **203 EDGEVALE RD**

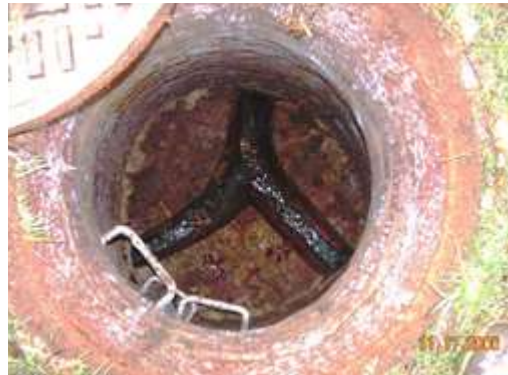
Top View

Bench debris.

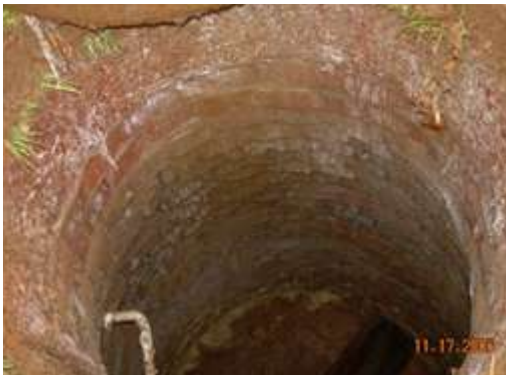
Defect

Condition: ☐ Sound ☐ Cracked ☐ Root Intrusion ☐ Loose Brick ☒ **Deteriorated**

Infiltration: ☐ None ☒ **Joint** ☐ Cracks ☒ **Mortar** ☐ Roots ☐ Wall

Infiltration: ☐ None ☐ Joint ☐ Cracks ☒ **Mortar** ☐ Roots ☒ **Wall**

Adjustment deterioration and infiltration.  
Corbel and Barrel infiltration.

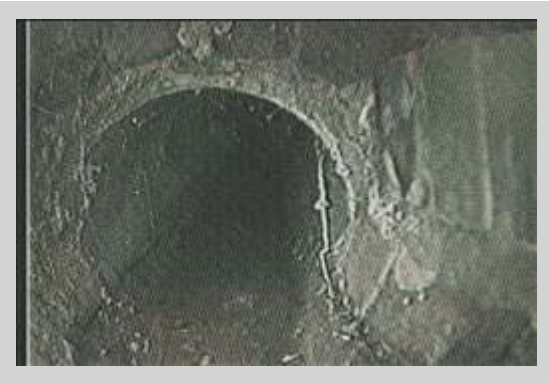
### 8 in. Circular Gravity Sewer Pipe Out @ 12 O'Clock

Infiltration: **Evidence** Pipe Seal Cond: **Roots**

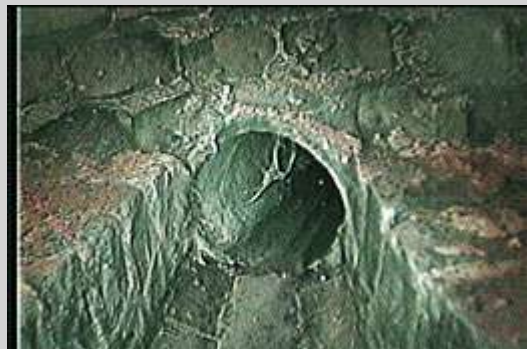
6 in. Circular Gravity Sewer

Barrel deterioration and infiltration.

Infiltration: **Evidence**
